Elastic-Plastic Nonlinear Response of a Space Shuttle External Tank Stringer: Part 1 – Stringer-Feet Imperfections and Assembly

Norman F. Knight, Jr. ¹
General Dynamics Information Technology, Herndon, Virginia

Kenny B. Elliott³, Ivatury S. Raju⁴, and Jerry E. Warren⁵ *NASA Langley Research Center, Hampton, Virginia*

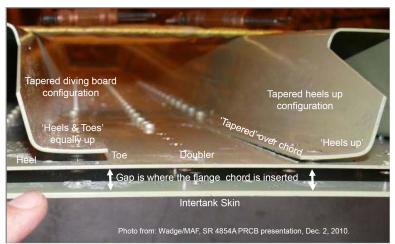
Figure 9. Various stringer-feet imperfections. Photograph courtesy of Mr. G. Wadge/LM-ET.

A stringer foot has a heel (i.e., transition between foot and region close to the stringer sidewall) and a toe (i.e., region close to the stringer free edge) as shown in Fig. 9. The center of the fastener holes is 0.44 inches from the

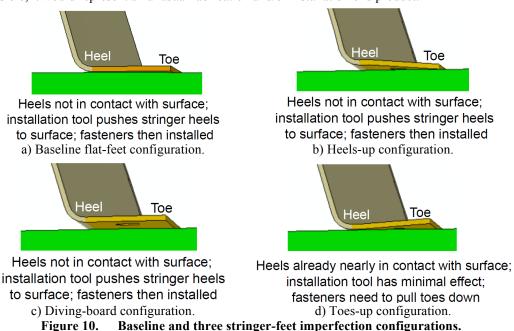
Four stringer-feet imperfection configurations are shown in Fig. 10. The baseline flat-feet configuration shown in Fig. 10a exhibits a toes-up condition due to the IT curvature. The heels-up configuration shown in Fig. 10b is defined as the configuration when the heels of the stringer feet at the end of the stringer are offset either 20, 40, or 60 mils further from the flat-feet configuration, while the stringer toes remain in the flat-feet configuration and linearly tapered across the stringer foot. The diving-board configuration shown in Fig. 10c has the heels and toes offset either 20, 40, or 70 mils from the flat-feet configuration (i.e., uniform offset with no tapering across the stringer foot). The toes-up configuration shown in Fig. 10d is when the toes of the stringer feet at the end of the stringer are offset either 20, 40, or 60 mils further away from the flat-feet configuration, while the stringer heels remain in the flat-feet configuration (linearly tapered across the stringer foot). However, the toes-up configuration has not been observed based on the inspection of spare stringers inventoried at MAF. 10 While the toes-up condition may be possible, it would represent an unusual fabrication and/or installation end product.

All of the stringer-feet imperfection configurations shown in Fig. 10 have a linear 'tapered' distribution from the maximum imperfection amplitude at the stringer end near Fastener 1 to the baseline flat-feet configuration between Fasteners 7 and 8. As discussed previously, the stringer hat, in all cases, is 'pushed' down towards the IT panel at least 5 mils after the rivets are installed and preloaded. Only the toes-up configuration (see Fig. 10d) after the 'push down' has a significant initial gap to close at the stringer-feet toes because the stringer-feet heels are already nearly in contact prior to any push-down loading.

For the heels-up condition shown in Fig. 10b, the peak strain values near each fastener for different stringer-feet imperfection amplitudes (20, 40, and 60 mils) are shown in Fig. 19. The peak total strains for this imperfection type are similar to those for the flat-feet configuration. Peak total hoop strain values occur near Fastener 4 as shown in Fig. 19. This response is due to the installation

For the diving-board condition shown in Fig. 10c, the total strain values near each fastener for different imperfection amplitudes (20, 40, and 70 mils) are shown in Fig. 20. These peak strain levels are similar to the strain levels for the flat-feet and heels-up configurations. Because of the installation procedure of pushing the stringer down prior to installation of the last eight fasteners, the peak assembly strains are not significantly different from those of the flat-feet configuration.

For the toes-up condition shown in Fig. 10d, the total strain values near each fastener for different imperfection amplitudes (20, 40, and 60 mils) are shown in Fig. 21. These strain levels are significantly different from those of the flat-feet configuration. For this imperfection type, the heels of the stringer feet cannot be pushed down to eliminate or minimize the distance the stringer

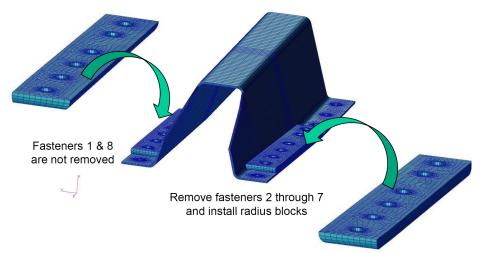
During the IT repair process following the cracking of the stringer feet on ET-137 prior to the STS-133 mission, radius blocks (see Fig. 13) are installed on most of these stringers on the IT/LOX-tank end. The simulation of the radius block installation reported here is for a 6-hole radius block 11 covering six fastener locations (i.e., Fasteners 2 through 7). 12 After the basic fastener installation simulation is completed, Fasteners 2 through 7 on each stringer foot are unloaded (i.e., their preload is removed) in one ABAQUSTM solution step, and then the radius blocks for each stringer foot are positioned and installed using 0.25-inch-diameter blind A286 steel fasteners with a preload of 290 pounds in a second solution step. These two additional solution steps complete the fastener installation and assembly process simulation for cases when radius blocks are installed.

Figure 13. Radius blocks for the IT LOX end long chord configuration.

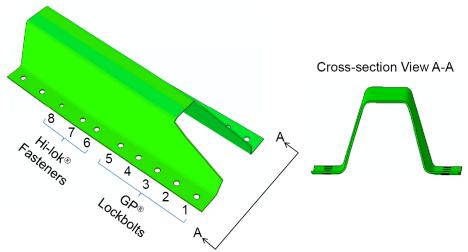
Figure 15. Baseline flat-feet stringer configuration with a cross-sectional view.

The influence of the stringer-feet imperfection type on the stringer end's deflected shape after assembly is examined for the four different stringer configurations shown in Fig. 10. Note that the end of the stringer has a tapered sidewall height without a hat section until just beyond Fastener 3 (see Fig. 15). Therefore, the stringer sidewall sections are free and unsupported for the first three fasteners near the end of the stringer.

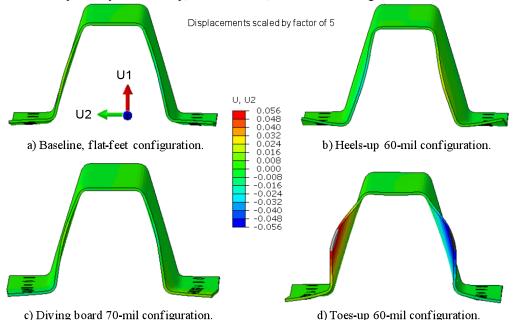
Scaled deformed shapes of the stringer end cross-section are shown in Fig. 16 for the four different stringer-feet configurations. The nodal displacements of the stringer measured from their original nodal locations are scaled by a factor of five in order to visualize the different deformed shapes resulting from assembly. Contour plots of the 'near' circumferential or hoop displacement component U2 are shown on the deformed shape as well with peak values being ±0.056 inches – the stringer thickness – indicating a large-deflection nonlinear analysis is required. The response of the baseline, flat-feet configuration due to assembly is shown in Fig. 16a. The feet toes deflect towards the IT surface and the stringer sidewalls deflect slight outward. The response of the heels-up 60-mil configuration

due to assembly is shown in Fig. 16b. The feet heels deflect towards the IT surface as a result of the 'push down' and the stringer sidewalls deflect inward with a peak deflection of roughly half the stringer thickness indicating the onset of large deflections. The response of the diving-board 70-mil configuration due to assembly is shown in Fig. 16c indicating a more uniform deflected shape for the stringer feet and a slight outward bending of the stringer sidewalls – more than for the flat-feet configuration but still small deflections. Finally, the response of the toes-up 60-mil configuration due to assembly is shown in Fig. 16d. The feet toes deflect towards the IT surface and the stringer sidewalls deflect significantly outward with a peak deflection more than the stringer thickness thereby requiring a large-deflection nonlinear analysis.

Figure 16. Cross-sectional views of the deformed shape of the forward end of the stringer after the assembly simulation.

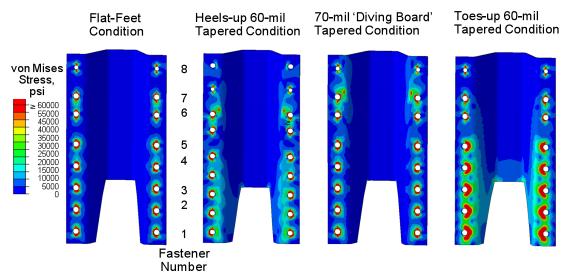
Fractography results¹² indicated that crack initiation likely occurred on the bottom of the stringer feet. Therefore, the analytical studies examined the elastic-plastic response on these surfaces. A comparison of the von Mises stress distributions on the bottom surface of the stringer feet for the flat-feet configuration and the different stringer-feet imperfection configurations with the maximum imperfection amplitude is shown in Fig. 17 for the first eight fasteners from the stringer end. In these contour plots, the contour levels range from zero as blue to values greater than 60,000 psi as red denoting the uniaxial stress level for the initial onset of yielding. These contour plots indicate that the uniaxial initial yield stress has been reached or exceeded in the vicinity of the fastener holes for all stringer-feet configurations. Only the toes-up configuration shown on the right side of Fig. 17 exhibits large high-stress regions around the GP* lock bolts (i.e., first five fasteners) that extends beyond the fastener head. These results indicate that localized plasticity will develop, as a minimum, around the first eight fasteners.

Figure 17. Von Mises stress distributions for the first eight fasteners after assembly – stringer-feet bottom surface.

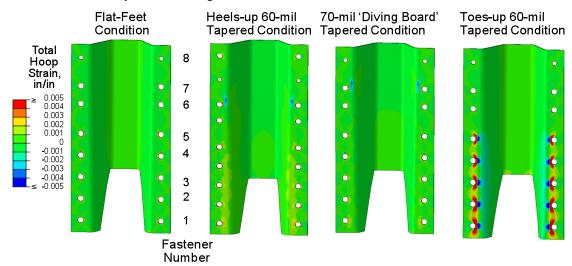
A comparison of the total hoop strain distributions on the bottom surface of the stringer feet for the flat-feet configuration and the different stringer-feet imperfection configurations with the maximum imperfection amplitude is shown in Fig. 18 for the first eight fasteners. In these contour plots, the contour levels range from values more negative than -0.005 in./in. (compression) shown as blue to values greater than 0.005 in./in. (tension) shown as red. The uniaxial strain at the elastic limit for this material is 0.005 in./in. or 0.5 percent. These results clearly indicate that only the toes-up configuration results in total hoop strains exceeding the uniaxial elastic strain limit and causing local yielding due to hoop strain alone. However, the results shown in Figs. 17 and 18 indicate that a combined stress state exists, and an elastic-plastic response near the first eight fasteners is anticipated to occur during the assembly step. Material testing has indicated that Al-Li 2090-T83 from suspect heat-treatment lots had a higher initial yield stress and a brittle fracture behavior just after initial yielding. Hence, these analysis results indicate the potential for an assembly strain level higher than the elastic limit.

Figure 18. Total hoop strain distributions for the first eight fasteners after assembly – stringer-feet bottom surface.

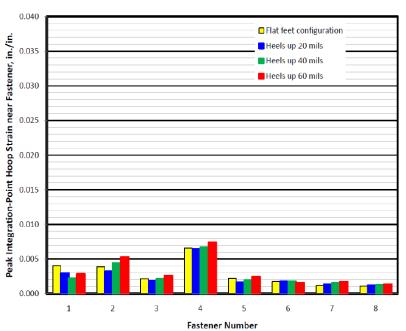
Figure 19. Peak hoop strain values near the first eight fasteners for the heels-up configuration for the assembly simulation.

procedure of pushing the stringer down to the IT panel surface before installing the last eight fasteners. Because of the push-down installation procedure, the heels-up configuration becomes nearly the same as the flat-feet configuration as indicated in Fig. 19. Also note that irrespective of the amount of imperfection, the peak hoop strain in Fastener 4 is nearly the same.

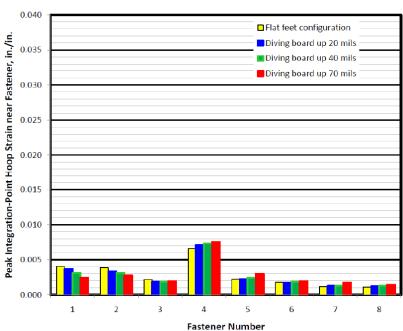
Figure 20. Peak hoop strain distributions near the first eight fasteners for the diving-board configuration for the assembly simulation.

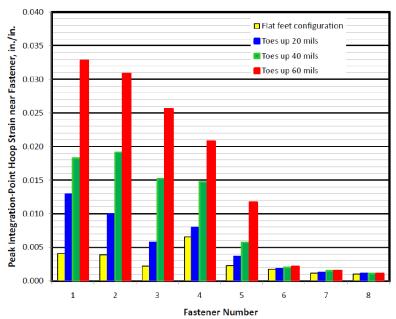
toes are above the IT surface. Consequently, the stringer feet are brought into contact with the IT panel surface through the installation of the last eight fasteners. As a result, a significant increase in local strain levels occurs. As indicated in Fig. 22, the peak total hoop strains for the toes-up condition for increasing imperfection amplitude

follow a similar trend with a peak value occurring within the element group at Fastener 1 and reaching over 3 percent strain for the maximum imperfection amplitude of 60 mils. The peak values are tensile total hoop strains, and these peak values occur between the fastener and the stringer sidewall along the bottom of the stringer feet. The strain levels decrease to the level of the flat-feet configuration as Fastener 8 is approached where the stringer-feet imperfection vanishes.

Figure 21. Peak hoop strain distributions near the first eight fasteners for the toes-up configuration for the assembly simulation.

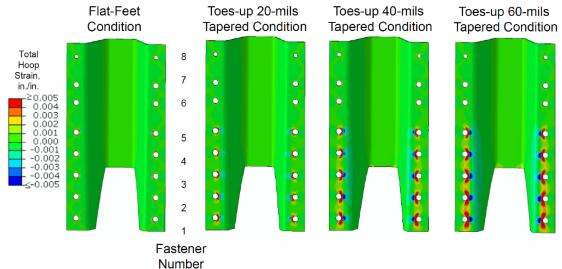
Figure 22. Total hoop strain distributions for the first eight fasteners after assembly for different amplitudes of the toes-up configuration – stringer-feet bottom surface.

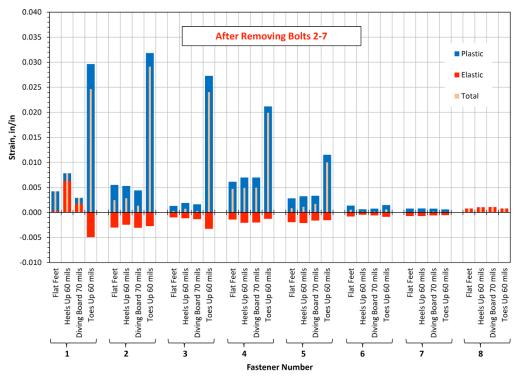
The second step is after Fasteners 2 through 7 have been removed in order to install the radius blocks. This step provides the initial conditions for the radius block installation procedure. The results shown in Fig. 24 indicate that plastic strains induced during the initial assembly (see Fig. 23) are locked in. Compressive elastic strains develop near all of the fasteners for all imperfections except near Fastener 1 for the heels-up and diving-board configurations. Recall that Fastener 1 remains installed for the radius block installation procedure.

Figure 24. Peak hoop strains for the first eight fasteners after removal of Fasteners 2 through 7 and prior to radius block installation for four stringer-feet configurations.

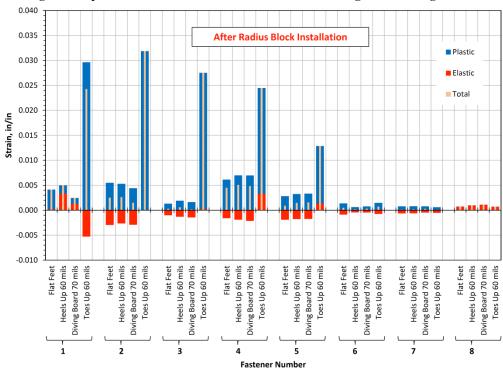
The third step is after the installation of the radius blocks. This step provides the initial conditions for the operational loads assessment for the stringer *with* radius block cases discussed in Ref. 4. The results shown in Fig. 25 are similar to the previous peak hoop strain distributions near the first eight fasteners. The only noticeable difference is the increase in peak strains near Fastener 1 for the heels-up configuration after the radius blocks are installed.

Figure 25. Peak hoop strains for the first eight fasteners after installing the radius blocks for four stringer-feet configurations.
